Manhole Inspection Summary

Manhole # S15II_030MH

Insp Date: **3/18/09 9:56 AM**

Location Address: **REAR 1738 BRADDISH**

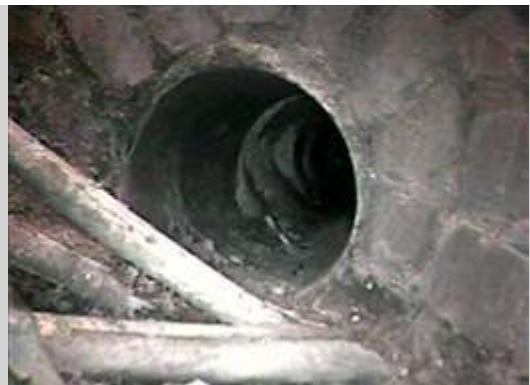
12 O'Clock Outflow

8 in. Circular Gravity Sewer
Pipe Out @ 12 O'Clock

Pipe Material: **Clay** ☐ Pipe Lined

Invert Depth: **5.20** (ft.) Flow Characteristics: **None**

Deposits: ☒ None ☐ Mud ☐ Sludge ☐ Debris ☐ Grease

Infiltration: **None** Pipe Seal Cond: **Sound**
